Insitu Geotech Services Pty Ltd

PLANT HAZARD ASSESSMENT

“ESME” – All-Terrain In Situ Testing Rig

Generic Project

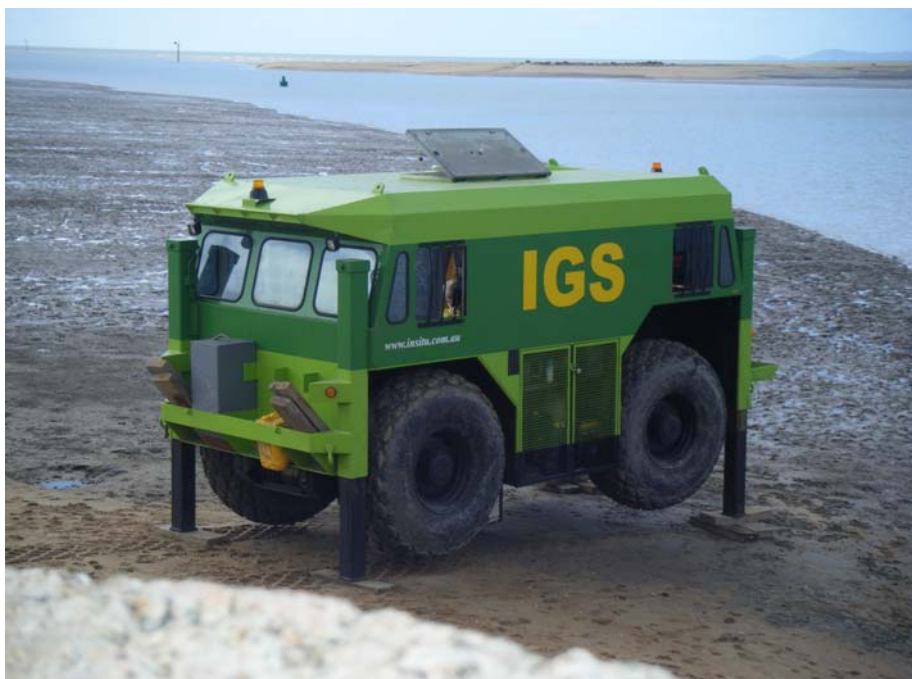
Rig Data & Purpose

- All-terrain rig on balloon tyres
- Year Built: 2000 (refurb 2009)
- On-board broadband
- Differential GPS
- Mass 11-22t adjustable
- Push capability (up to 200kN)

Drive is fully hydraulic with radial piston motor on hub of each wheel. Tyre pressures are adjusted as required to suit terrain.

Diesel engine is mounted fully external to cabin (at end not visible in this photo). External mounting ensures quiet work space inside cabin and positive isolation from engine heat and exhaust fumes.
