Insitu Geotech Services Pty Ltd

PLANT HAZARD ASSESSMENT

RIG: "EUNICE" – Truck-mounted Testing Rig
SITE/PROJECT: Generic Project

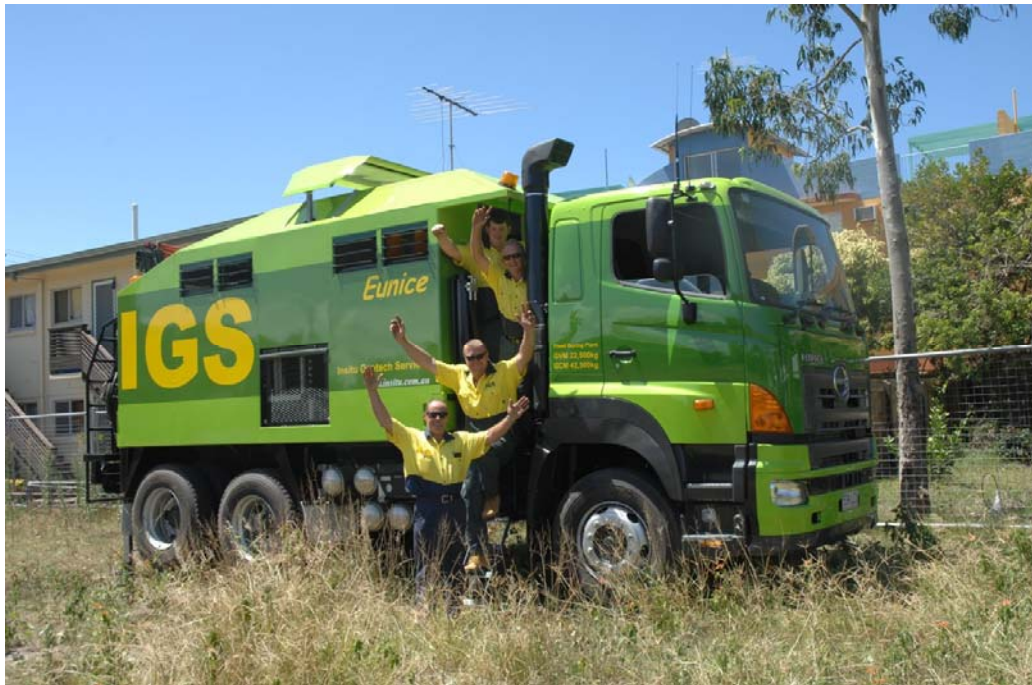
Purpose-built rig on 6x4 Hino 700 Truck Base

Year Built: 2009 Registration: 539-LCU

On-board broadband

Differential GPS

Mass 22t

Push capability (up to 200kN)

Test Types:

- Geomil CPT & CPTu
- Tee-Bar
- DMT & SDMT
- Vane Shear
